**KOROZJA I OCHRONA KATODOWA STALI ZBROJENIOWEJ
W BETONOWYCH OBIEKTACH BUDOWLANYCH
NARAŻONYCH NA ODZIAŁYWANIA ATMOSFERYCZNE**

**CORROSION AND CATHODIC PROTECTION
OF REINFORCING STEEL IN ATMOSPHERICALLY
EXPOSED CONCRETE STRUCTURES**

John Peter Nicholson
NACE Accredited Senior Corrosion Technologist

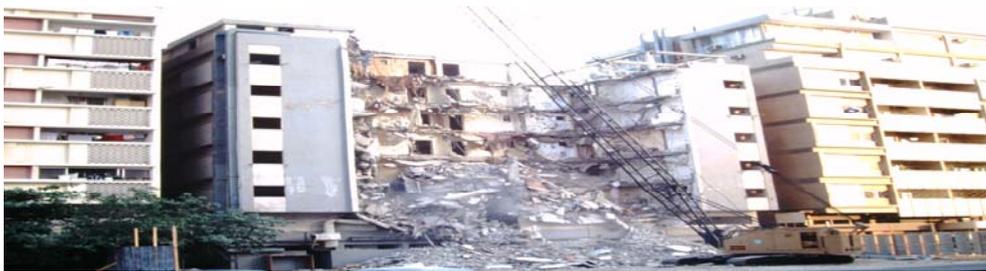
Fig. 1. Seventeen Year Old Building Being Demolished in Abu Dhabi due to Corrosion Damage

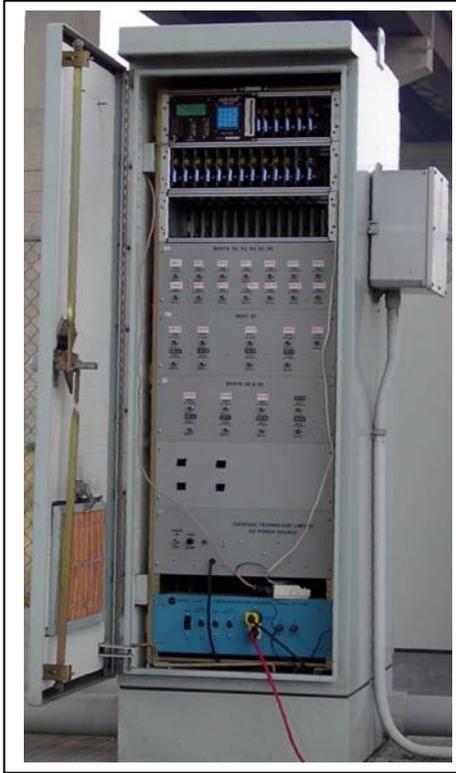
Fig. 2. Electronically Controlled Multi-circuit Rectifier

This electronically controlled rectifier has eighteen individually controlled circuits capable of operating in constant current, constant potential or auto-potential modes and includes data logging and remote control.

Four rectifiers comprising 65 independent control zones powered the cathodic protection system. The computer controlled rectifiers supplied low voltage DC current to the anode panels. This DC current then flowed from the rectifier to the anode panels then through the concrete finally to be collected on the reinforcing steel where it returned to the rectifier. This DC current substantially reduced the corrosion rate of the reinforcement resulting in extended life of the structure.

During normal operation of the system, the rectifiers momentarily interrupted the DC current flow and logged the INSTANT OFF potential of the reinforcement as measured between the permanently installed silver-silver-chloride reference electrodes and the reinforcing steel at the programmed interval.

The computer-controlled rectifiers could be programmed to perform depolarization tests whereby the output current was halted for a period of time, usually seven days. The rectifiers logged the potential of the reinforcement as measured between permanent silver-silver-chloride reference electrodes embedded in the concrete at a programmed interval, usually every 10 minutes. Normal practice is an annual test.
